FRP Molded Grating Drop Test Report

Impact Testing of Various 1-1/2" Deep Walkway Gratings

Molded Grating Drop Test Report

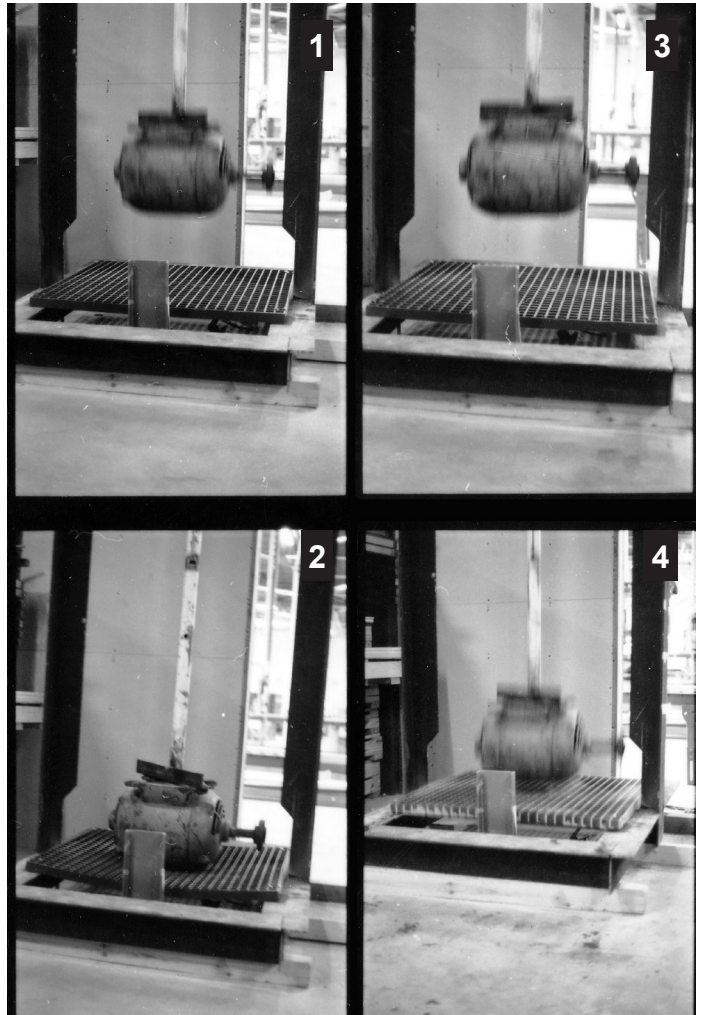
FIG. 10 - Drop Test Deflection and Rebound of FRP Grating Taken During Filming, 9 - Drop Test Sequence Stills Taken During Filming

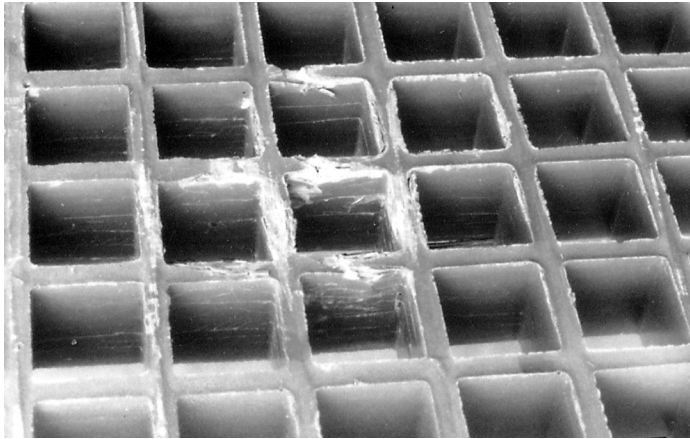
Figures 9 and 10 are stills taken during the filming sequences. Figures 11, 12 and 13 are close up views of the upper and lower surfaces' damage at the conclusion of the test of sample 16. Figures 14 and 15 are views of the test of the galvanized grating. This grating sustained permanent deformation, approximately 3-3/8", as shown in Figure 14. Numerous welds were cracked and broken at the various intersections of the tie rod and span bar as shown in Figure 15.

FIG. 11 - Still of Impact Damage to FRP Grating

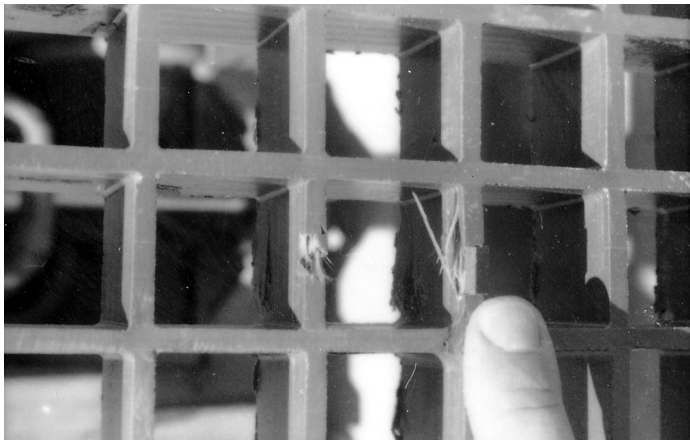
1. For the purpose of this report, splintering refers to a delamination of the glass bundles in the actual direction of the bar. Generally, this splintering did not exceed 2" to 3" in length nor exceed the lower 1/4 of the bar height (Fiberglass products). This normally involved up to three bars directly under the corners of the impact head.

FIG. 12 - Closeup of Impact Splintering

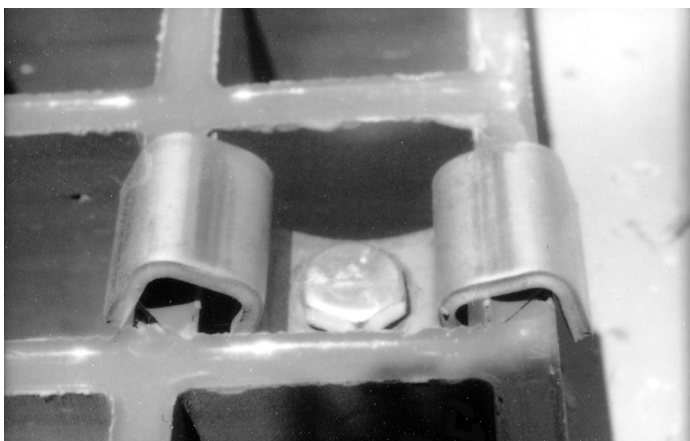
FIG. 13 - Closeup of Impact to Clip Area

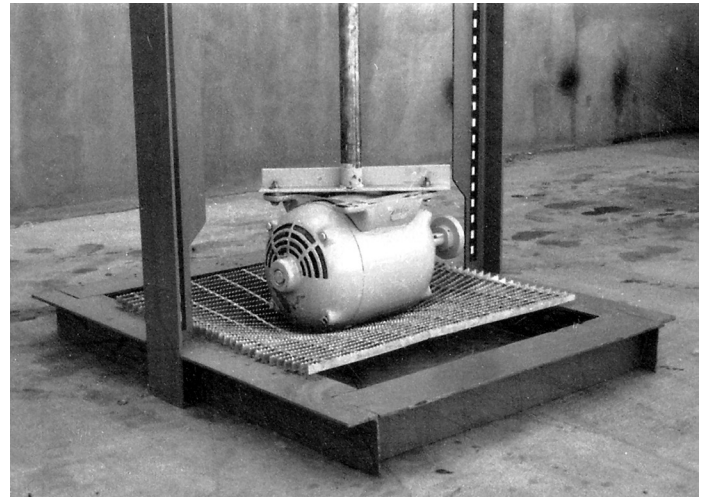
Fig. 14 - Still of Impact Damage to Steel Grating

The total difference in damage can be attributed in part to the different resin systems. No effort is made herein to analyze these influences. The galvanized steel grating underwent permanent deformation with the initial impact. Welds were broken with the force of the impact. This level of damage would require immediate replacement in service.

Test 5, Sample 17 was the galvanized steel grating constructed from flat bar and tie rods welded at each intersection. The drop was from full height. The initial impact caused permanent deformation of the grating to a depth of 3-3/8". A significant number of tie bar welds (about 40%) were broken. Figures 14 and 15 are an overall and closeup view of these results.

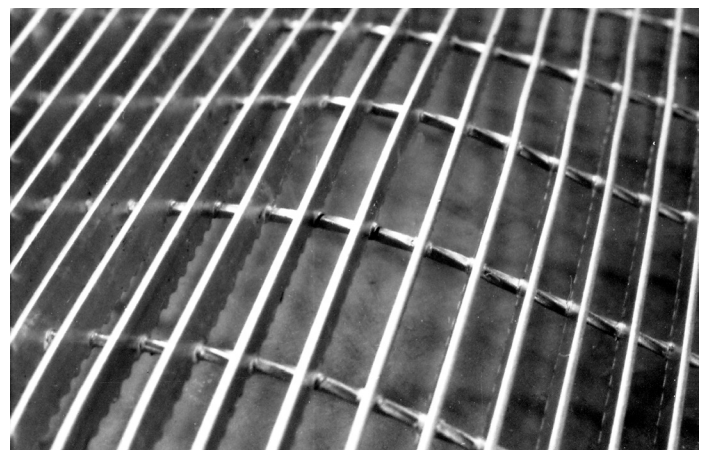
Fig. 15 - Closeup of Impact Damage to Steel Grating
